**43rd Turbomachinery
30th Pump SYMPOSIA**

INVESTIGATION AND ANALYSIS OF HIGH THRUST BEARING TEMPERATURE AFTER FIELD OVERHAUL AND RERATE OF A CENTRIFUGAL COMPRESSOR

CASE STUDY 2014 TAMU TURBO SYMPOSIUM

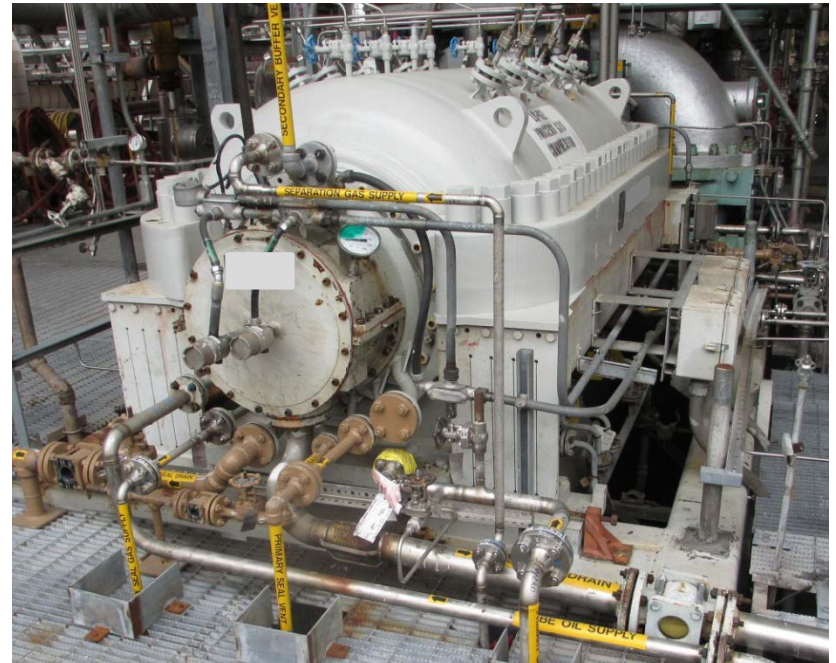
Machine Background Information

- High pressure casing of charge gas train
 - 30 khp 2 section, five stage, back to back, centrifugal compressor with unbalanced seals
- Compressor rerated as part of a plant turn around
 - 1st section was rewheeled
 - Balance piston size increased
 - Retrofitted with dry gas seals
- Thrust Bearing Design
 - 10-1/2", 39 in², self leveling, copper backed, offset pivot, flooded lube
 - Compressor design speed 4812 to 6400 rpm.
 - Same bearing as before rerate
